NASA TN D-3205

INVESTIGATION OF THIN FILMS AS FLOATING LINERS FOR FIBER-GLASS CRYOGENIC PROPELLANT TANKS

by Robert W. Frischmuth, Jr.

*Lewis Research Center
Cleveland, Ohio*

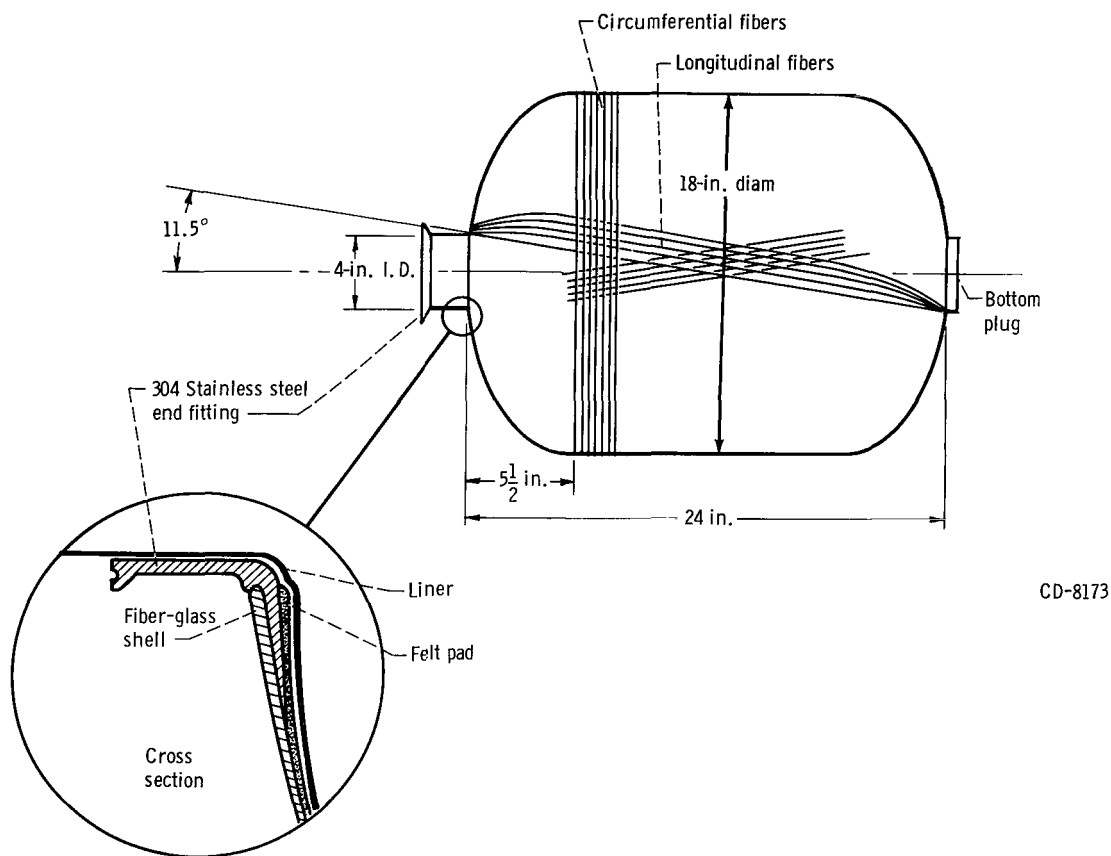
Figure 1. - Design of filament-wound tank.

A conventional winding pattern consisting of a longitudinal and circumferential wrap was used (fig. 1). The longitudinal wrap was of a standard balanced-in-plane design, reference 7, with a winding angle (angle between a fiber-glass strand and the longitudinal axis of the tank) of 11.5° . The contour of the ends of the shell was of the isotenoid (refs. 1 and 7) type consistent with the balanced-in-plane wrap.

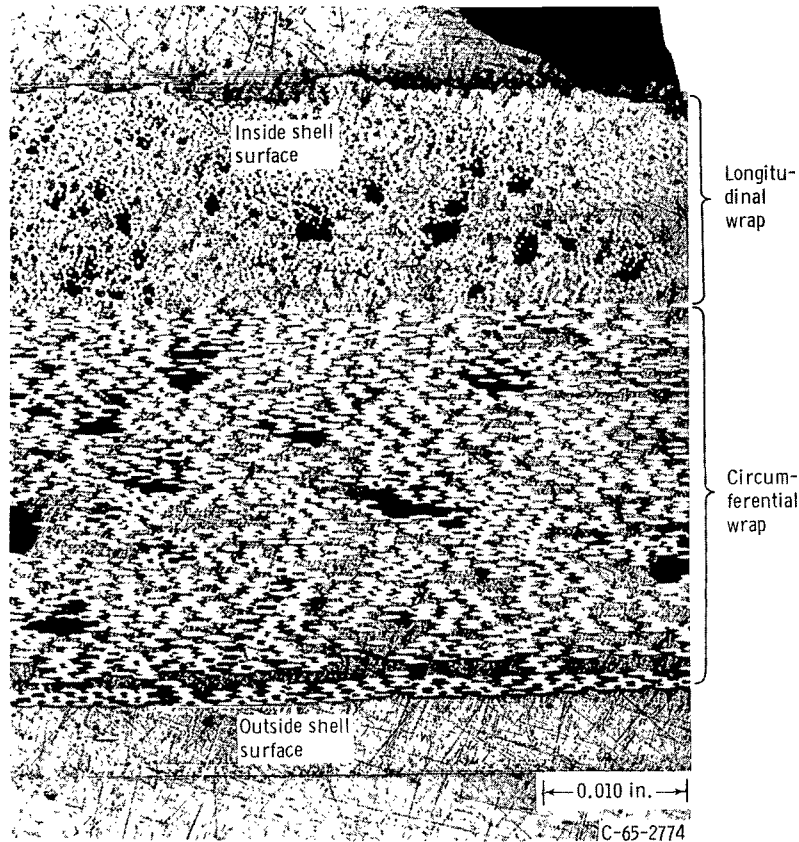
Figure 2. - Photomicrograph of filament-wound shell cross section.

Figure 2 is a photomicrograph of a typical cross section in the cylindrical portion of the shell. The cross section was taken perpendicular to the half of the longitudinal wrap that runs at a winding angle of $+11.5^\circ$ (the other half of the longitudinal wrap runs at -11.5°). The white dots in the top of figure 2 are the longitudinal filaments. Although half of the longitudinal wrap was cut at an angle of 67° , the cross sections of these filaments do not appear to be ellipses since their eccentricity is small. The ellipses in the lower part of figure 2 are circumferential filaments (cut at an angle of 11.5°). The black areas are voids. From photomicrographs such as figure 2 the following can be calculated:

- (1) Strand density of longitudinal wrap, 392 strands/in.
- (2) Strand density of circumferential wrap, 799 strands/in.
- (3) Glass content by volume, 52.7 percent
- (4) Thickness of shell, 0.047 in.

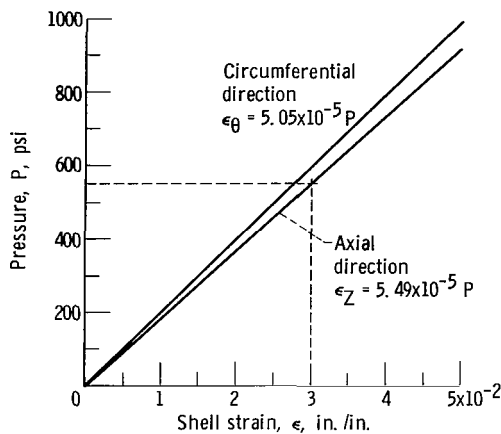
Figure 3. - Calculated shell strain as function of pressure at room temperature.

Using the method outlined in reference 3, the relation between shell strain and pressure $\epsilon(P)$ can be calculated and is shown in figure 3. Now, the ultimate strain of "E" glass is about 5 percent (ref. 1). However, when fiber glass is used in a filament-wound vessel, the ultimate strain of the glass is reduced due to imperfect packing of the longitudinal fibers as they cross over each other in the vessel domes, and imperfections such as variation in resin content, broken fibers due to handling, nonuniform winding tension, and nonuniform strand distribution. A realistic ultimate shell strain is about 3 percent (ref. 1) which corre-

sponds on figure 3 to a burst pressure of about 550 pounds per square inch. The reason the shell was built this strongly is that there is a practical limit on how thin a fiber-glass shell can be made. Consider the area of the dome at the transition to the cylindrical portion of the tank. Here the surface is not covered by circumferential strands and consequently the wall is thinner here than anywhere on the shell. The dome wall gets thicker as the axis of the vessel is approached due to overlapping of the longitudinal strands. The minimum strand density that can be used in this thin area to adequately support the liner is determined by one layer of adjacent strands. Assuming hexagonal close packing of the individual filaments within the glass strands, the minimum strand density of the type of strand used in this tank is about 370 strands per inch for the longitudinal wrap.

enough to being balanced (see fig. 3, p. 8) that the preceding relation can be used in place of equations (A12) and (A13) (criterion for liner integrity for a shell of unbalanced design derived in the appendix). This simplification will, in this case, introduce a possible error of less than 10 percent which is well within the accuracy of the property data used. The values used in this inequality are as follows:

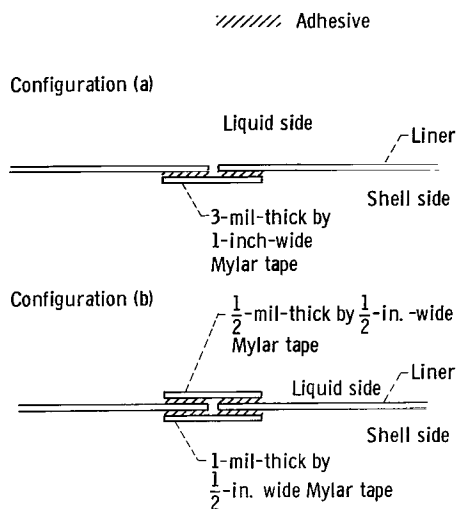
Figure 4 - Adhesive joint configuration for Mylar liners.

The seams were butt joints covered with Mylar tape. Two slightly different joint configurations were used. The configuration shown in figure 4(a) was used on liner 3. As shown later in the results, this configuration did not give a reliable leak-tight seal. Therefore, the design was modified as shown in figure 4(b).

Liner 3 was built to see what materials and fabrication techniques should be used on the remaining liners. The felt pad in the lower dome worked satisfactorily, so it was decided to extend the pad to cover the entire inner surface. The test showed the adhesive joints to be mechanically strong, but unreliable leak-tight seals at -423°F . Therefore the design of the joints was changed to that previously shown in figure 4(b) (p. 10).

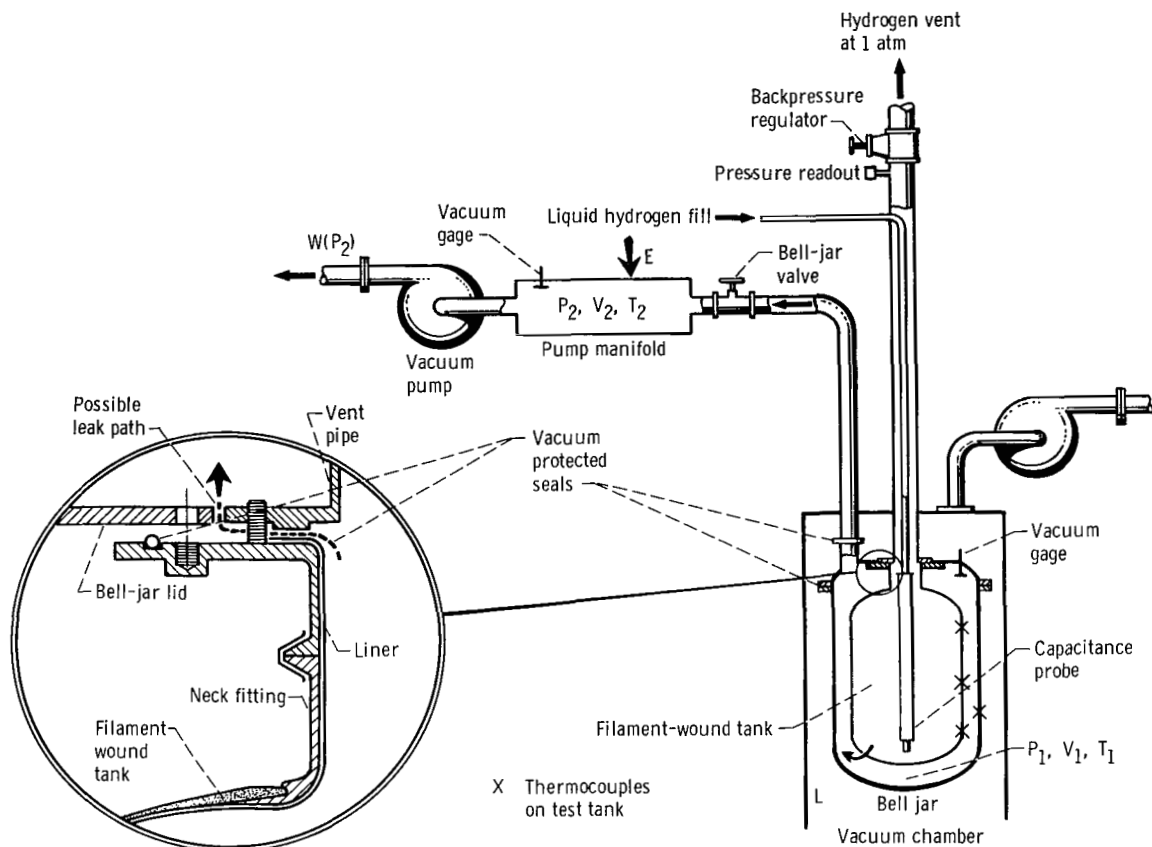
Figure 5. - Liquid hydrogen facility for tank liner tests.

Figure 5 shows the facility that was used for the tests with liquid hydrogen. The tank was mounted in a bell jar which had a twofold purpose. First, the vacuum in the bell jar insulated the tank so that it could be kept full of liquid hydrogen for a reasonable length of time. Secondly, the bell jar provided a fixed volume so that the leak rate of the tank could be determined by rate of change of pressure in the bell jar.

The instrumentation (also shown in fig. 5) consisted of:

- (1) A pressure transducer of the strain gage type
- (2) A capacitance type liquid level probe

- (3) Hot filament type vacuum gages used in the determination of leak rate of the tank
- (4) Copper-constantan thermocouples located on the outer surface of the filament-wound shell and bell jar

For determining small leak rates the bell-jar valve (shown in fig. 5) is kept closed. The leak rate corrected to standard conditions of temperature and pressure, is then given by the simple expression:

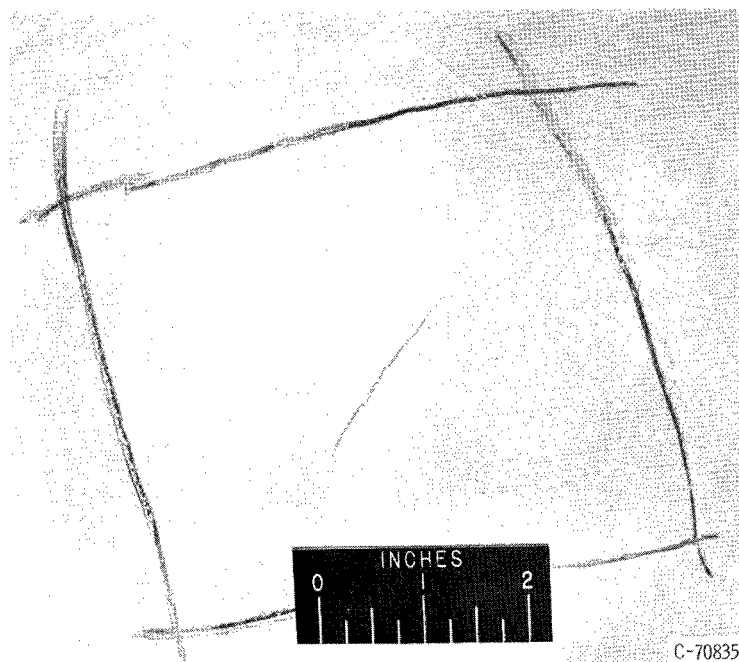
Figure 7. - Failure of liner 2 (Teflon).

Liner 2 (Teflon). - The initial helium leak rate was about 0.4 standard cubic centimeter per second. An attempt was made to oversize the liner by pressurizing the tankage system at room temperature. Teflon has a tendency to cold flow when stressed for a period of time. As the pressure was slowly increased the liner unexpectedly failed at a tank pressure of only 96 pounds per square inch gage (as shown previously at a tank pressure of 550 psi the shell strain is 3 percent; the ultimate strain of Teflon is over 200 percent at room temperature). Examination of the tank showed a crack (fig. 6) in the upper dome of the fiber-glass shell near the transition to the cylindrical portion (the area of lowest filament density). Although the resin cracked, this cannot be considered a shell failure since there were very few, if any, broken filaments. Figure 7 shows the area of the liner that corresponds to the location of the crack in the shell. It appears that the liner failure was caused by the internal pressure forcing the liner into the crack. This failure led to the use of the felt spacer on succeeding tanks.

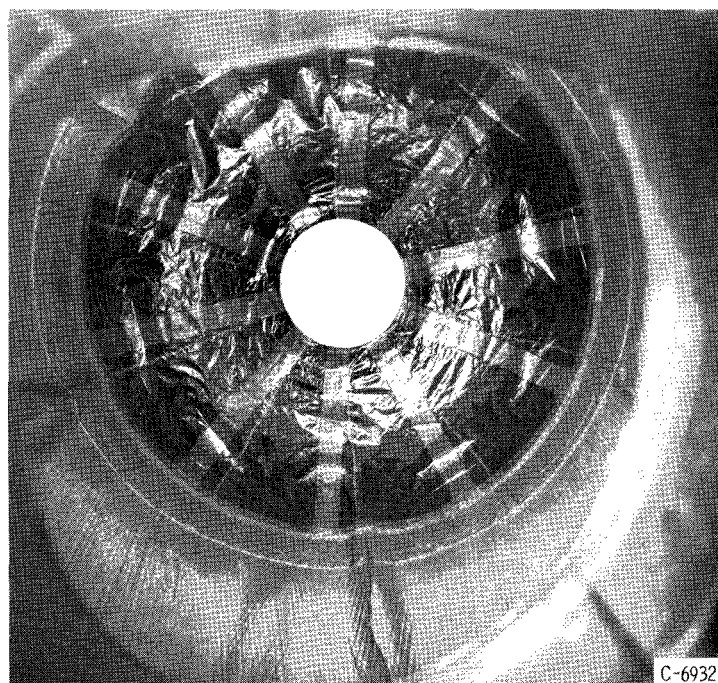
Figure 8. - Liner 3 (Mylar domes, aluminum-Mylar cylindrical section) after testing with liquid hydrogen.

Figure 8 is a photograph taken through the neck fitting of the tank after testing. The lower dome and part of the cylindrical portion is shown. The stitching in the felt (used in the lower dome only) can be seen through the Mylar-Mylar laminate used in the lower dome. In the cylindrical portion an impression of the longitudinal filament-winding pattern can be seen in the Mylar-aluminum-Mylar laminate lining material.

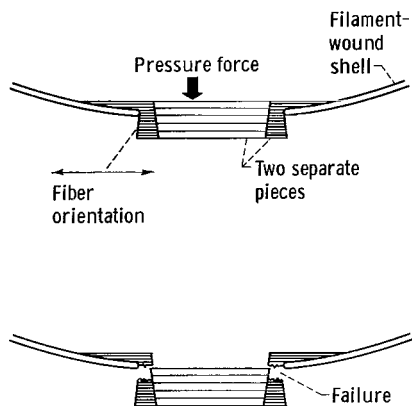
Figure 9. - Cross section of bottom end fitting of fiber-glass shell.

temperature cycled three times at atmospheric pressure using liquid hydrogen. No increase in helium leak rate was noted. Before pressure cycling at -423°F , it was necessary to check the test apparatus by pressurizing the tank with helium at room temperatures. At about 200 pounds per square inch, the bottom plug blew out of the fiber-glass shell thus ending liner 4. The bottom fitting, made of fiber glass and resin, was made in two parts (fig. 9) to allow for a shaft to support the mandrel during the winding of the shell. The glass fibers were oriented in the wrong direction for carrying a tensile load in the region of the failure.

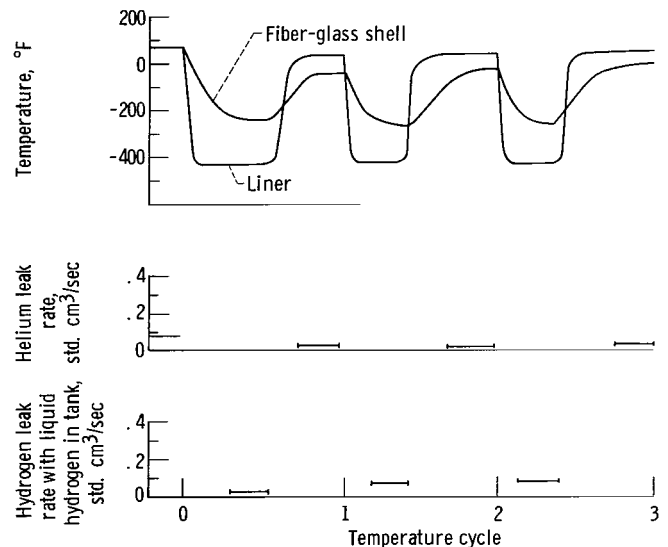
Figure 10. - Temperature cycling liner 5 (Mylar laminate) with liquid hydrogen at a tank pressure of 1 atmosphere.

Liner 5 (Mylar laminate) test results. - The initial helium leak rate was about 7×10^{-2} standard cubic centimeter per second at room temperature and a pressure of 1 atmosphere. The tank was put through three thermal cycles, using liquid hydrogen, without any increase in leak rate (see fig. 10). The temperature of the fiber-glass shell (fig. 10) never approached the temperature of liquid hydrogen (-423°F). At 1 atmosphere tank pressure the fiber-glass shell cooled to a steady-state temperature of -270°F . This was due to the insulating quality of the felt spacer, which was in this case evacuated to approximately the same pressure as the bell jar (average of about $10\mu\text{Hg}$). Thermal conductivity of the evacuated felt spacer was calculated to be 3×10^{-4} Btu per hour per foot per $^{\circ}\text{F}$. It should be pointed out that this tank could not be tested in the air since air would be cryopumped into the felt. The saturation of the felt with liquid air would not only be dangerous, but would destroy the insulating quality of the felt.

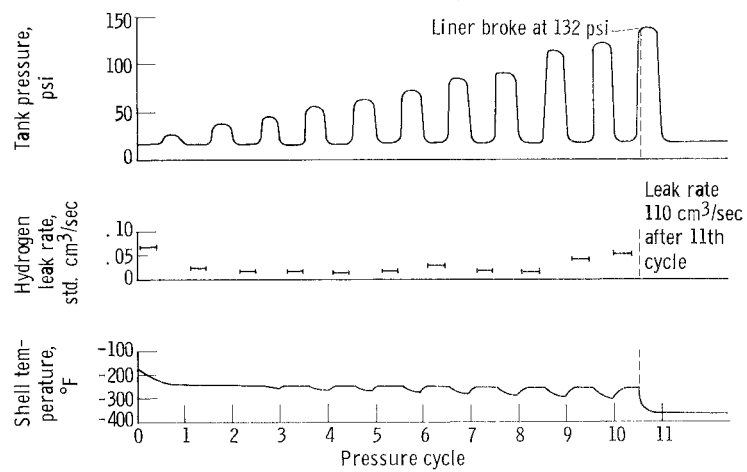
Figure 11. - Pressure cycling liner 5 (Mylar laminate) with liquid hydrogen in tank.

Next the tank was pressure cycled, as shown in figure 11, with liquid hydrogen in the tank. The leak rate, measured after each pressure cycle, was found to be less than 5×10^{-2} standard cubic centimeter per second for the first 10 cycles indicating no damage

to the liner. On the eleventh cycle, when the pressure reached 132 pounds per square inch, the leak rate suddenly increased. After the pressure was dropped back to 1 atmosphere the leak rate measured 110 standard cubic centimeters per second indicating the liner broke. Also at the time the liner failed, the shell temperature suddenly dropped (fig. 11). The felt pad lost its insulating quality due to the loss of vacuum.

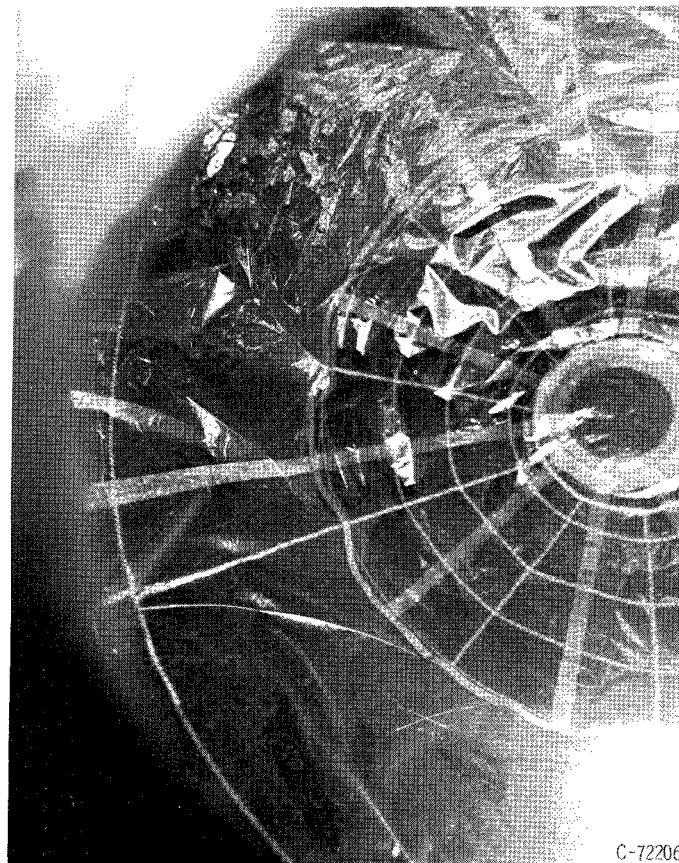
Figure 12. - Liner 5 (Mylar laminate) after failure. Photograph taken with liner in place.

Liner 5 (Mylar laminate) analysis of failure. - Figure 12 is a photograph of the liner after testing, taken through the neck fitting of the tank. As expected, there is some wrinkling. There are several very sharp folds or creases. To further investigate, the liner was removed from the fiber-glass shell.

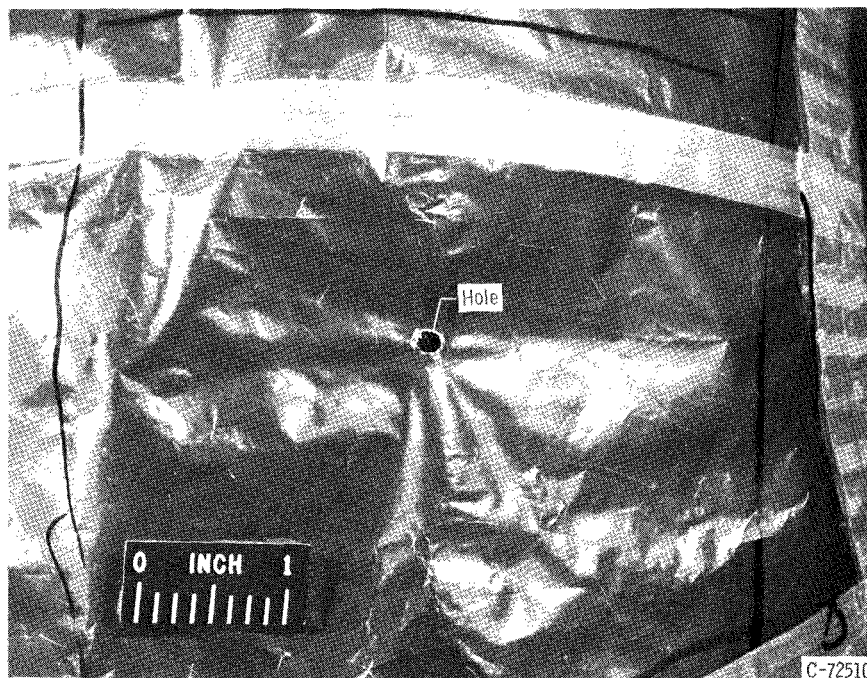
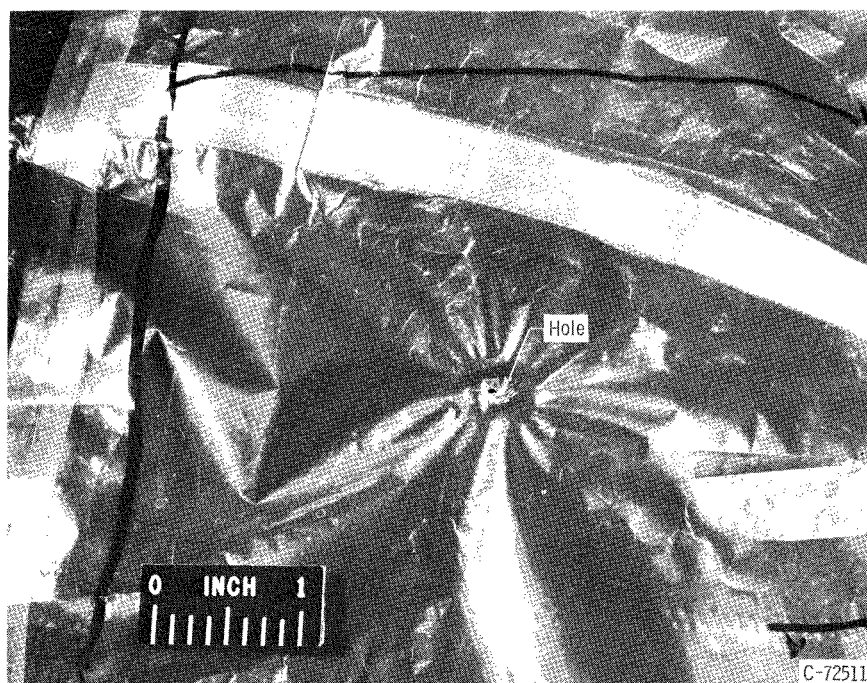
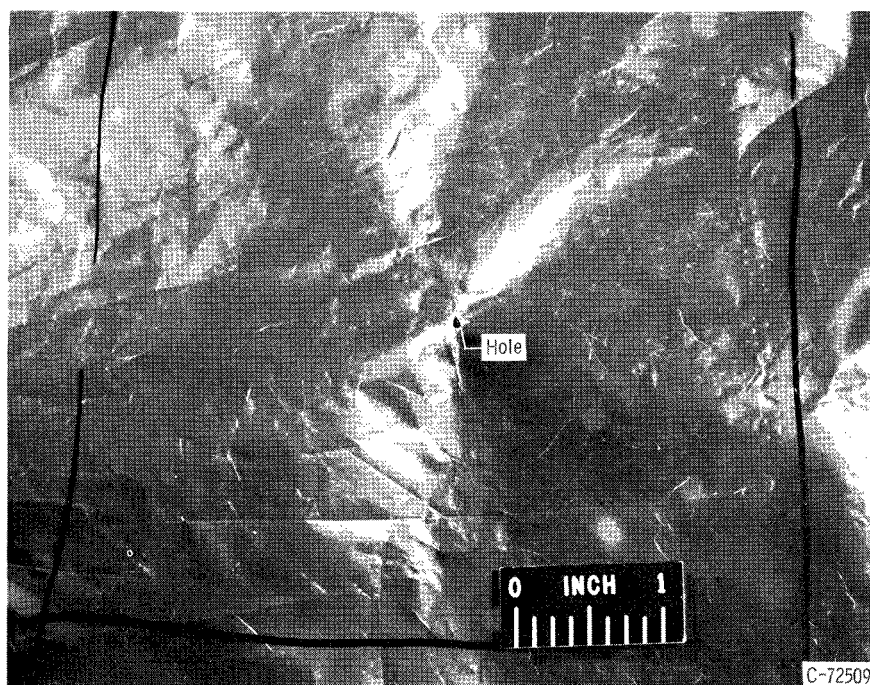
The leak source was found to be three rather large holes. Two of the holes were located in the upper dome (figs. 13 and 14), and one in the cylindrical portion (fig. 15). Also, after a thorough examination, no visible leaks were found in either the adhesive joints or on the sharp folds or creases just mentioned. The holes shown in figures 13 to 15, were believed to be biaxial tensile failures.

Figure 13. - Leak in liner 5 (Mylar laminate) in upper dome.

Figure 14. - Leak in liner 5 (Mylar laminate) in upper dome.

Figure 15. - Leak in liner 5 (Mylar laminate) in cylindrical portion.

Therefore, theoretically the liner should fail in tension at about 118 pounds per square inch. This is in good agreement considering the accuracy of the preceding data with the 132 pounds per square inch at which the liner actually failed, supporting the belief that holes shown in figures 13 to 15 are the results of a biaxial tensile failure. The

reason the appearance of figures 13 to 15 is not typical of conventional biaxial tensile failures such as the bursting of a pressure vessel, is that with the rupturing of the liner there was no sudden release of energy since the tensile load due to pressure was carried by the filament-wound shell.
